Failure Analysis of Jet Boat's Wear Ring and Impeller.

Properties of Materials (ME 3034) December 2nd 2016

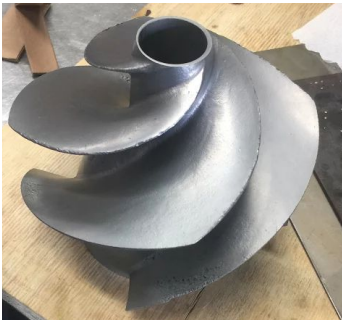
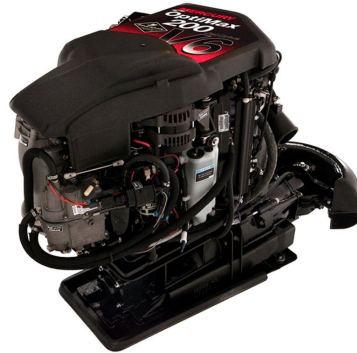
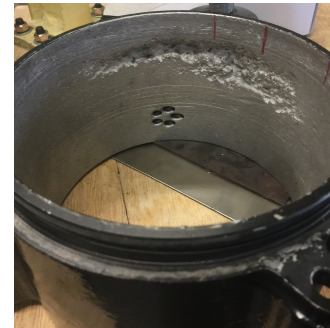
Summary Figure 1,2,3 (left to right)

The part that failed was from Mercury Marine Sports Jet 2010 model, figure 2. We analyzed 2 similarly damaged components, the wear ring and the impeller; Figure 1, and 3 respectively.

There are a couple recommendations that would likely fix this failure. One is to add a plastic liner that fits along the outside of the wear ring. Also, using JB weld to fill in the cavitated areas can help restore performance. One last way to improve this would be to change the material of the impeller to something more resistant to cavitation, such as a higher grade stainless steel. There may not be a need to redesign the part if the reason for failure was due to unusually extreme temperature from the engine, or running it at too high RPM. In which case

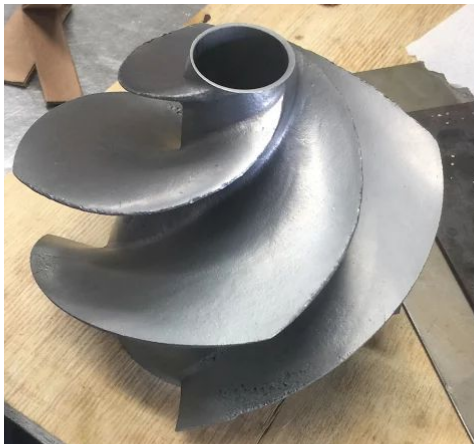
Visual Examination Figure 1,2

Once receiving the wear ring and impeller there were several noticeable problems. On the blades of the impeller there was an even distribution of cavitation (Figure 1,2). There was at least some cavitation on each separate blade in the same spot. With the wear ring, there was a large area of cavitation that was centered around the exhaust port (Figure 3,4). There was more

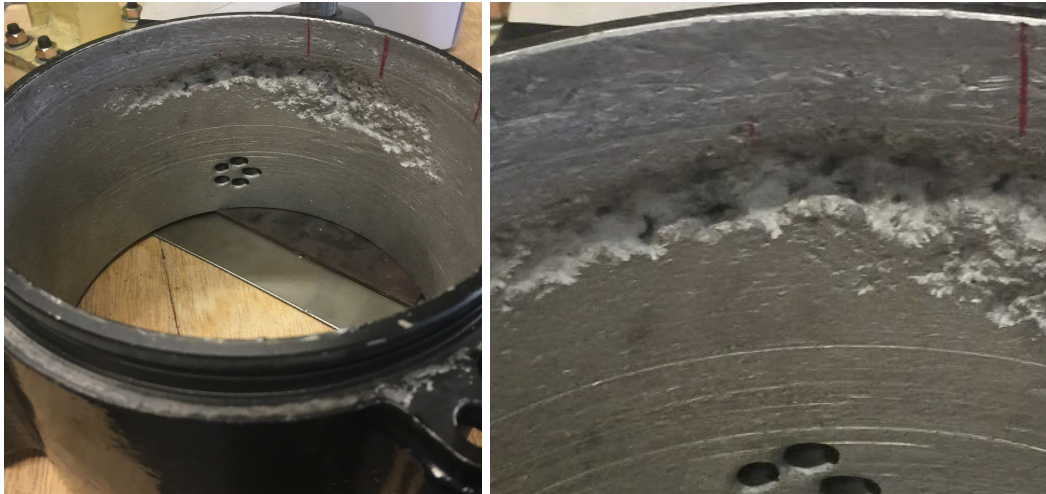
Visual Examination Figure 3,4

cavitation to the right of the exhaust port than the left, following how a fluid would flow through the ring. On the bottom of the ring there was very slight cavitation. Using the casting number of both parts, we were able to determine that they came from a 2010 Mercury Marine Sports Jet.

The failure of these parts occurred because the exhaust port was overheated. When the hot fluid from the engine came through the port and into the wear ring, the metal lost its original hardness level. We know this because of our hardness testing. It shows that the metal is more weak near the exhaust port compared to metal that is on the other side of the ring. Because of this, cavitation occurred in a large amount right over the exhaust port. Once the fluid was out of the port and in the ring, it flowed to the right and made that part of the ring lose its hardness as well. The cavitation got deep enough to the point where it broke through the wall and into the exhaust port creating a hole. The cavitation that occurred on the impeller is normal cavitation that would occur over time from use.

- 1) Use JB weld to fill in cavitated areas to restore factory performance.
- 2) Switch the material of the impeller to something more resistant to cavitation, such as a higher grade stainless steel, to improve the lifetime of the part. The
- 3) Use a removable plastic wear ring liner that can be replaced for \$14.99.
- 4) Check the engine for overheating and run maintenance if necessary.
- 5) Limit max revolutions per minute to avoid overusage.

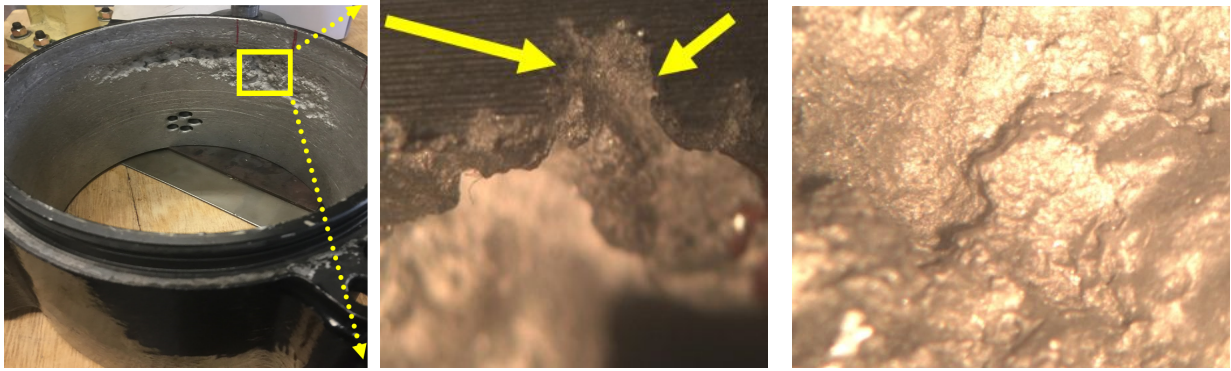
Microstructural Examination Figure 1,2,3 (left to right)

Low magnification (at middle: 20X, at right: 50X) microscope pictures of surface damage on Aluminum Wear ring. Cavitation Damage Profiles on surface edge are highlighted with arrows.

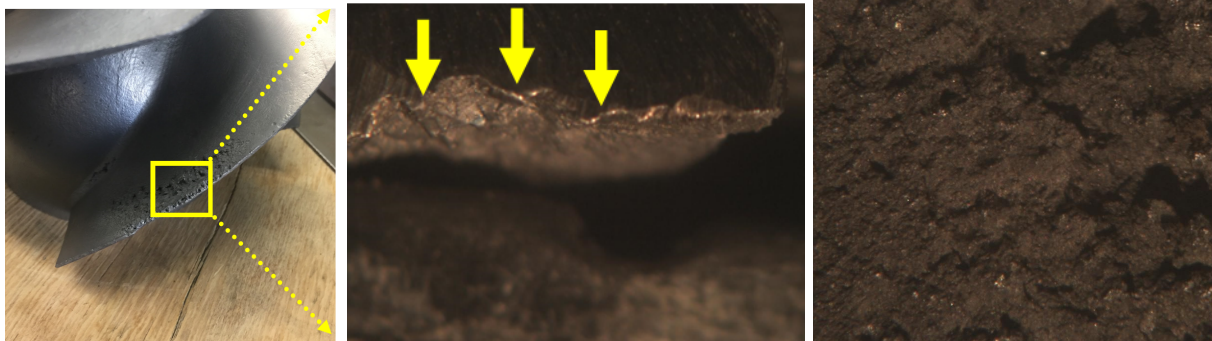
Microstructural Examination Figure 4,5,6 (left to right)

Low magnification (at middle: 20X, at right: 50X) microscope pictures of surface damage on Stainless Steel Impeller. Cavitation Damage Profiles on surface edge are highlighted with arrows.

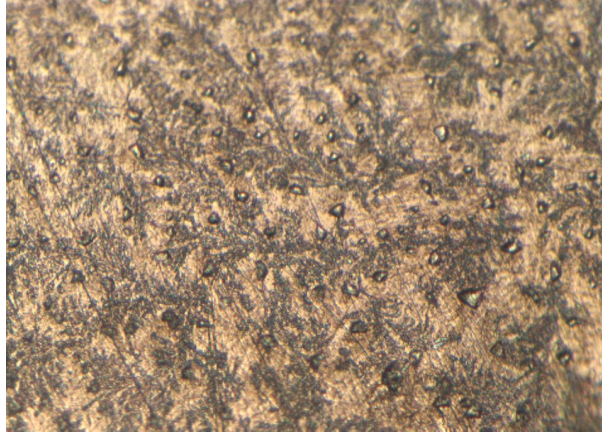
*Low magnification (50X) microscope Pictures of Grain Structure of Stainless Steel Impeller
Microstructural Examination Figure 7*

According to the manufacturer, Mercury Marine, the X7 stainless steel alloy is “30% stronger and 4x more durable than conventional stainless steel”. The details of the materials that go into the X7 alloy and the heat treatment it receives are not published or otherwise available. The large particulate dots in the grain structure may be the result of a precipitation hardening treatment. This is highly likely, considering that it would advantageously harden the impeller without reducing durability if treated properly, and also stainless steels may contain many different secondary elements that could precipitate out: manganese, chromium, nickel, molybdenum, nitrogen, copper, titanium, phosphorus, sulphur, selenium, niobium, silicon, cobalt and calcium. Based on the appearance, the precipitate could likely be chromium. The ultimate tensile strength of the X7 Stainless Steel Alloy is found to be approximately 112 ksi from our hardness testing data and microstructural photographs.

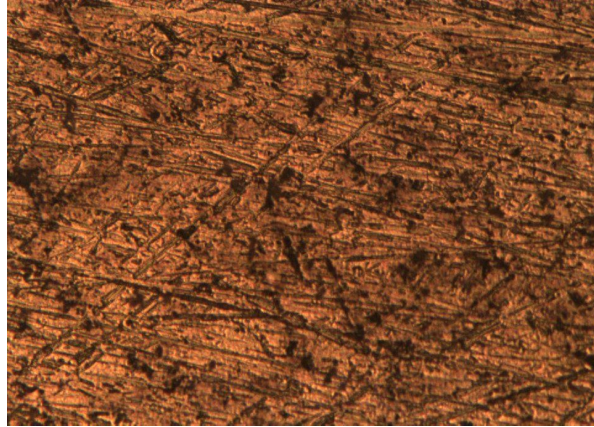
*Low magnification (50X) microscope Pictures of Grain Structure of Aluminum Wear Ring
Microstructural Examination Figure 8*

The grain structure can be seen in both microscope photos, although significant scouring is seen in the aluminum microstructural photo. The ultimate tensile strength of the XK360 Aluminum Alloy is found to be approximately 49.3 ksi from our hardness testing data and microstructural photographs, Figures 7 and 8 and Table 1.

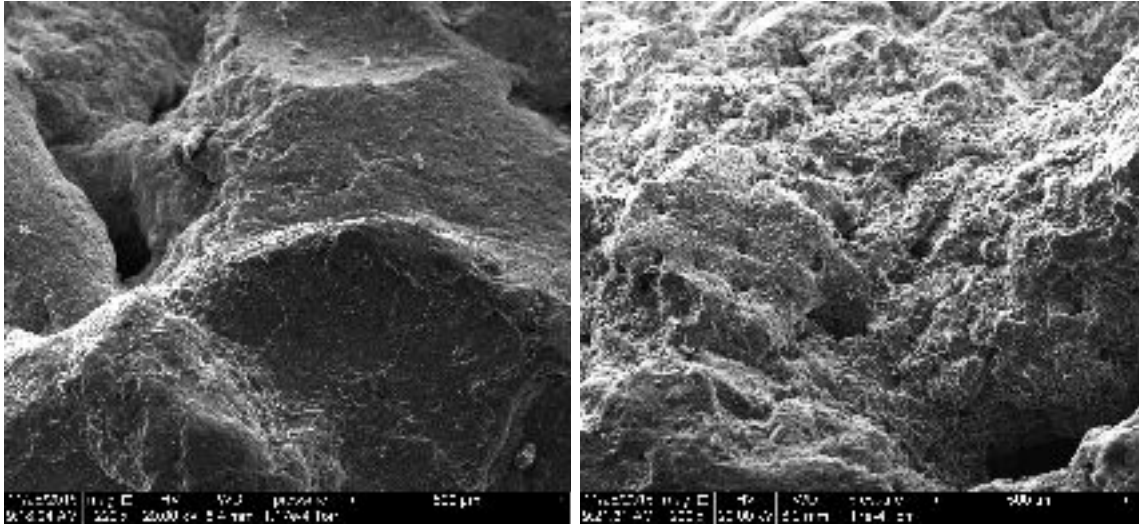
Scanning Electron Microscopy was also used, to better understand what was happening during the damaging event, and to rule out various other theories about the source of the damage such as corrosive or particulate-impact damage. Grain structure boundaries appear to be visible in some of the photos, seen especially in the second photo of Figure 9. The “sponge-like” surface is a well-known indicator of cavitation damage; additionally, the size and orientation of the ridges appear to be the direct result of a cold-working process. Should these ridges show any form of cratering or directionality, particulate impact damage could be a cause, however this is not seen in our photographs.

Microstructural Examination Figure 9,10: SEM pictures of wear ring @ ~220x

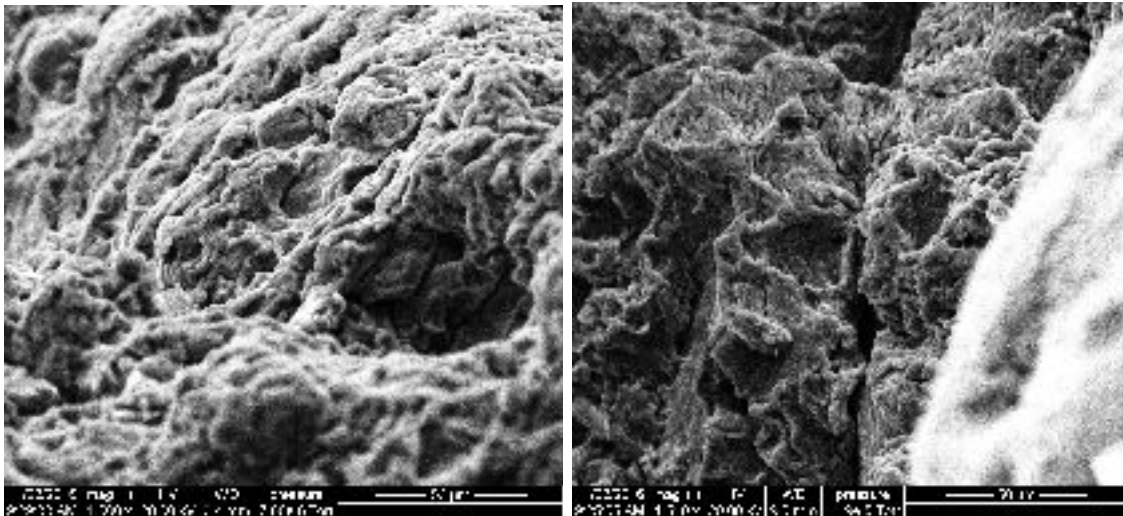
Microstructural Examination Figure 11,12: SEM pictures of wear ring @ ~1600x

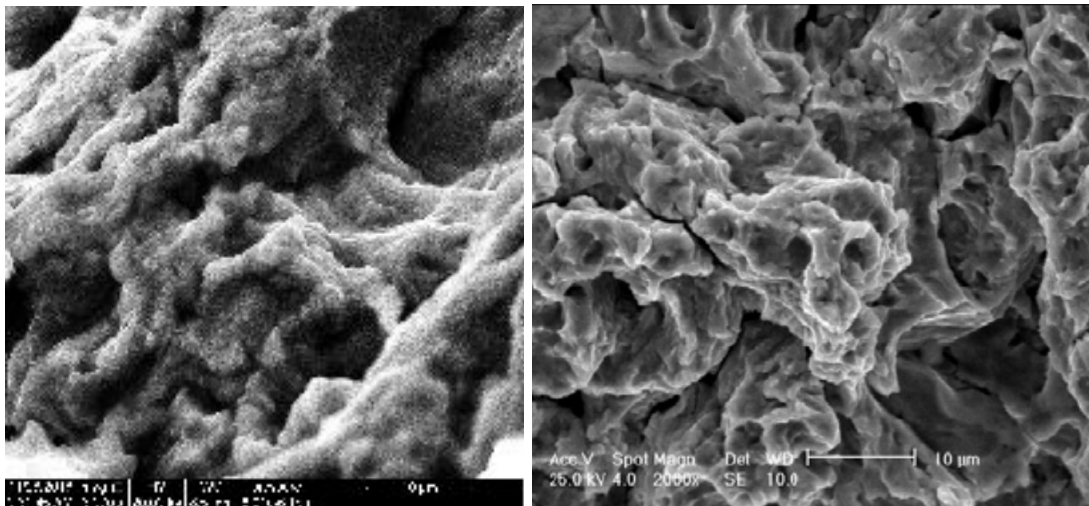
Microstructural Examination Figure 13,14: SEM @ ~6000x (Left) vs Reference (Right)

The Scanning Electron Microscope photos showed direct evidence of cavitation when compared to reference images of similar metals. This experiment also served to rule out the possibility of chemical damage, as no evidence of corrosive or particulate-impact damage.

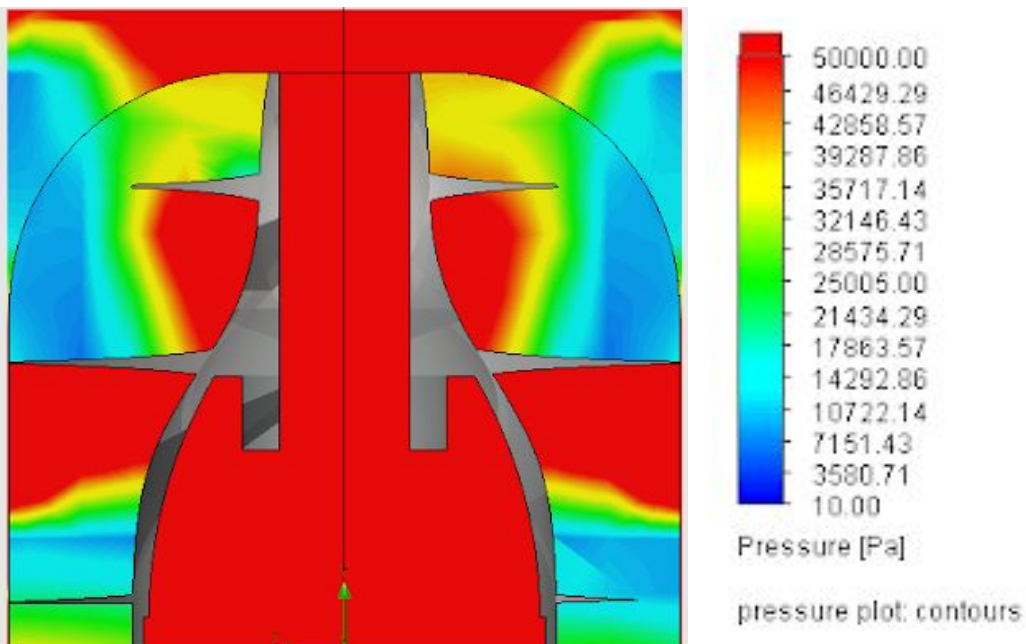
Pressure Plot (CFD Figure 6)

The pressure plot below, figure 6, models the pressure of the fluid as it flows through the wear ring. At room temperature fluid normally vaporizes at less than 3,300Pa. On this diagram you can clearly see areas as low as ~7,000Pa or less right near the blades. While this does not definitively show vaporization, it is so close to the vaporization point compared to normal 101.3kPa pressure, that there is at least partial vaporization. Additionally the temperature from the engine means that the fluid will likely start to vaporize at higher pressures as seen in the phase diagram, figure 7.

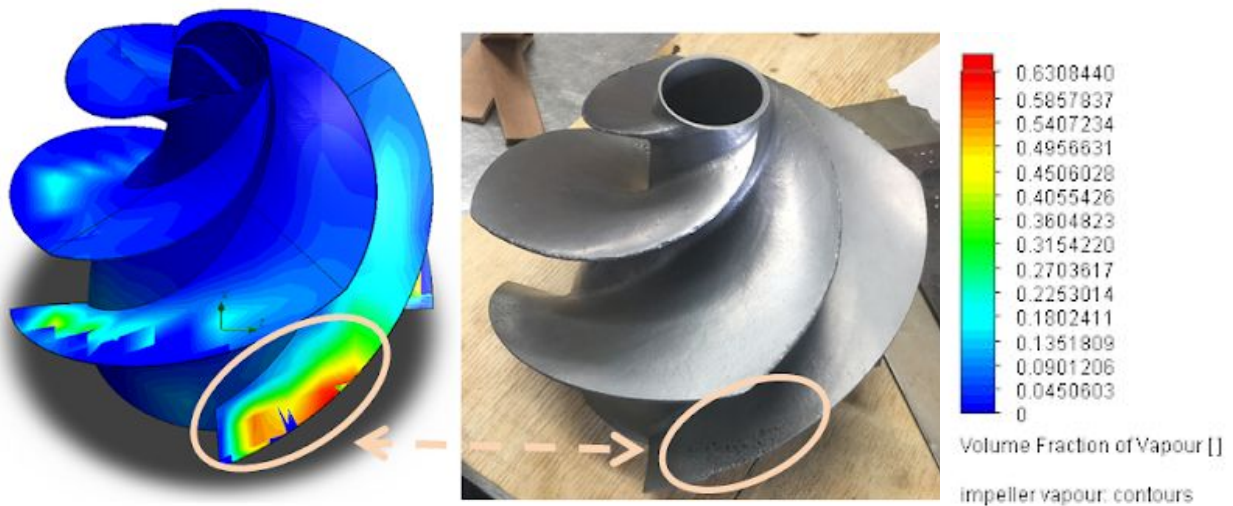
3D fluid vaporization plot (CFD Figure 8)

Figure 8 and Figure 9 both model the percent of vapor on the impeller. Figure 8 indicates there is at the highest point ~60% vapor. This shows that there are a lot of bubbles that are forming and subsequently crash into the metal of the impeller causing damage when they turn back into liquid. This is indicative of cavitation. It also has the highest percent vaporization in the same region on the real part, showing that this is a good model to predict the damage.

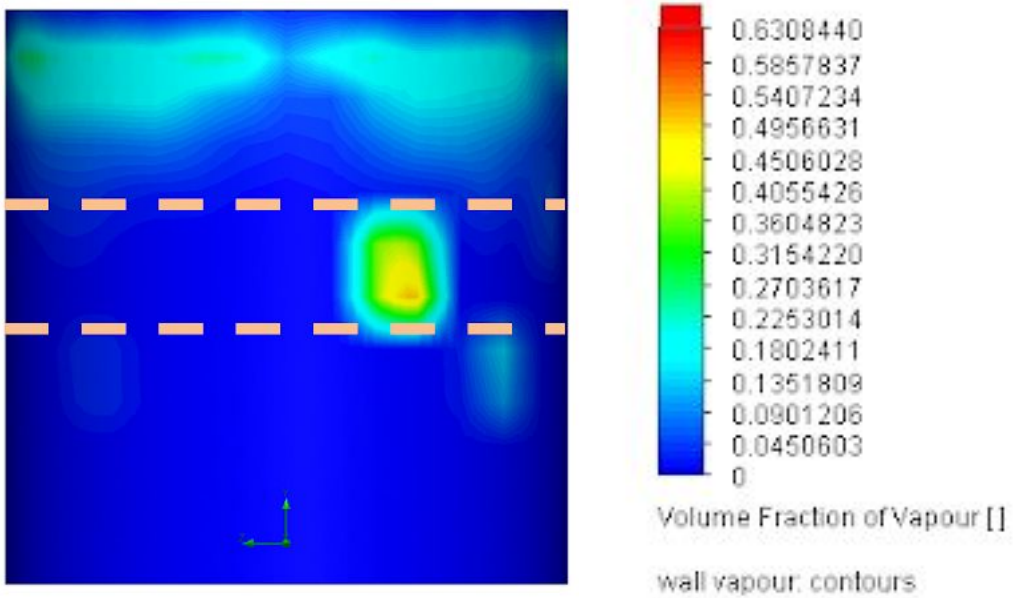
Wear ring inside damage (CFD, Figure 11)

Figure 11 and 12 picture the plot of percent fluid vapor on the wear ring. The dotted lines in figure 11 represent where the plot should actually be. It should look like that one localized region all between the dotted lines. This is because solidworks cannot model rotating bodies, only rotating fluid. Effectively that means the relative to the wear ring, the impeller is not moving, but the fluid is rotating around the impeller giving it the same effect, but interfaces like these won't be modeled perfectly. The localized region in figure 11 is actually where the blade is closest to the edge, which you can see in the 3D model in figure 12. The percent vaporization of this wear ring is at max about 40% and the dotted lines also represent where the failure is on the real part. further helping to confirm the theory of cavitation.

The percent fluid vapor plots in the CFD analysis correlate almost perfectly with the damage observed. Most notably the wear ring percent fluid vapor plot, CFD figure 11, models vapor exactly where the wear ring took the most damage. These computations serve to link vaporization of the water with the damage. Vaporization bubbles are the primary causes for cavitation, which means that this CFD analysis models the damage most likely as cavitation on the exact areas it was damaged. Furthermore, The comparison between the 3D impeller vapor plot, CFD figure 8, and the real part picture, CFD figure 9, also shows that the where the most percent vapor is located, is where it was damaged on the real part. Further supporting the theory of cavitation.
