Failure Analysis of a Marine Impeller and Wear Ring

Rhiannon Caldwell
Spenser Pulleyking
Ryan Ogilvie
Yutong Wu

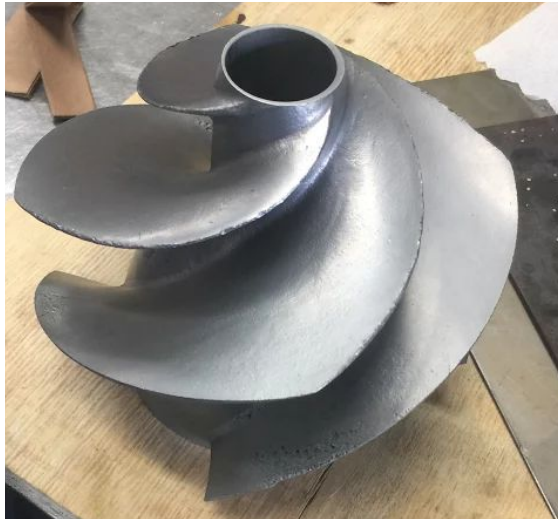
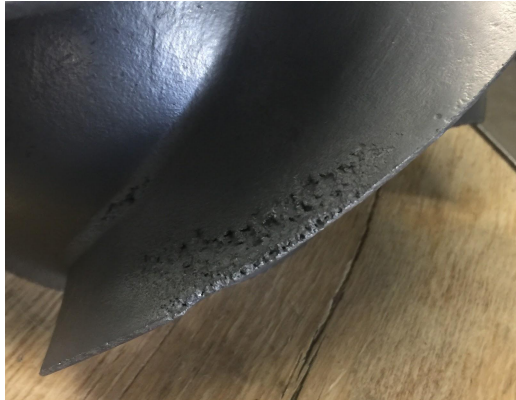
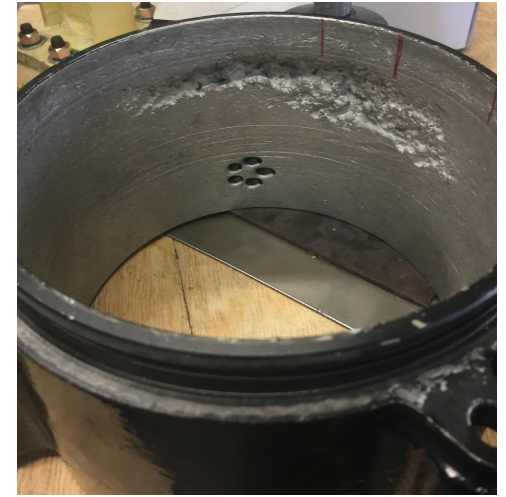
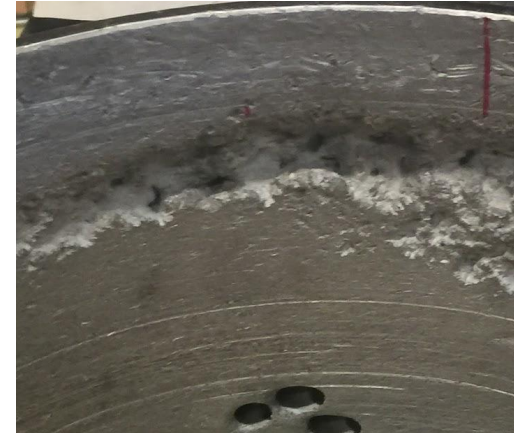
Visual Observations

- Main Reason: Heat from engine and exhaust port softened the aluminum, allowing for a large section of cavitation
- Other Possible Reasons:
 - Chemical erosion on wear ring
 - Rejected: Orientation does not support
 - Normal cavitation on the impeller and wear ring
 - <10% BEP leads to cavitation
 - Not enough information for a BEP calculation or a NPSH curve
 - Rejected: Damage is localized as opposed to diffuse

- Similar Impeller - Wear Ring Designs, such as those by Seadoo, use a removable plastic wear ring cover that can be easily replaced for ~\$14.99
- Regular Maintenance/Repair: Multiple online forums suggest that using JB weld to fill in cavitated areas is an effective way to repair the part and restore factory performance
- The cavitation damage seen on the impeller appeared to be standard cavitation damage over time (not a failure) thus replacement of the impeller is still a necessity at some point. Switching to a more cavitation-resistant material (such as stellite) would improve this lifetime.

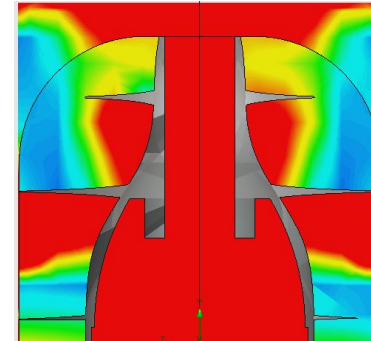
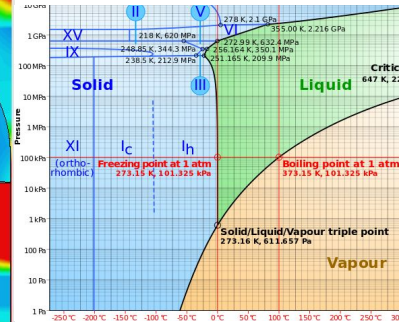
- Pressure Plot
 - Dark blue represents below vapourization point for room temperature
 - Phase diagram plot shows the switch between liquid and vapour
 - normal pressure 101,300Pa

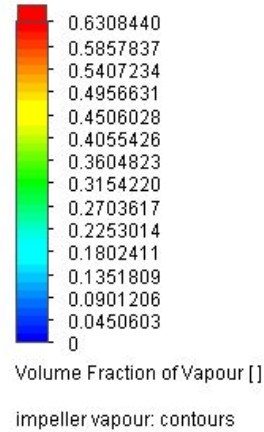
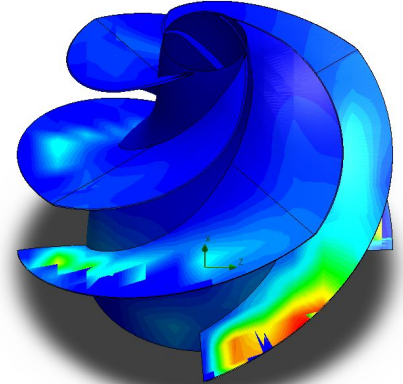
- Percent Fluid Vapourization on impeller
 - red represents about 60% vapour
 - vapour points are where it cavitated on real object.

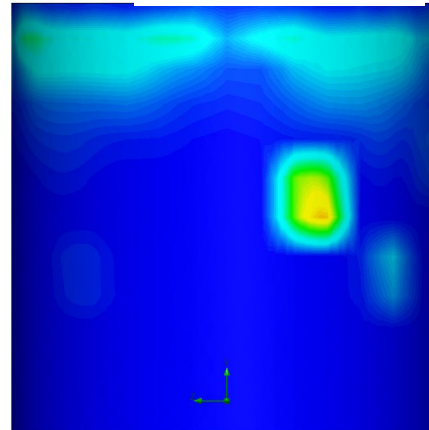
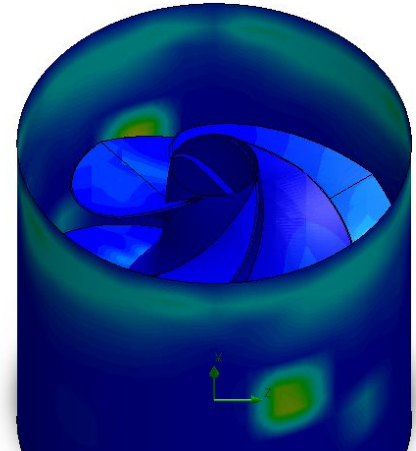
- Percent fluid vapourization on wear ring
 - ~45% vapourization
 - The localized point circles the entire wear ring (because solidworks models it as rotating fluid with a stationary part)
 - correlates with cavitation on real wear ring.

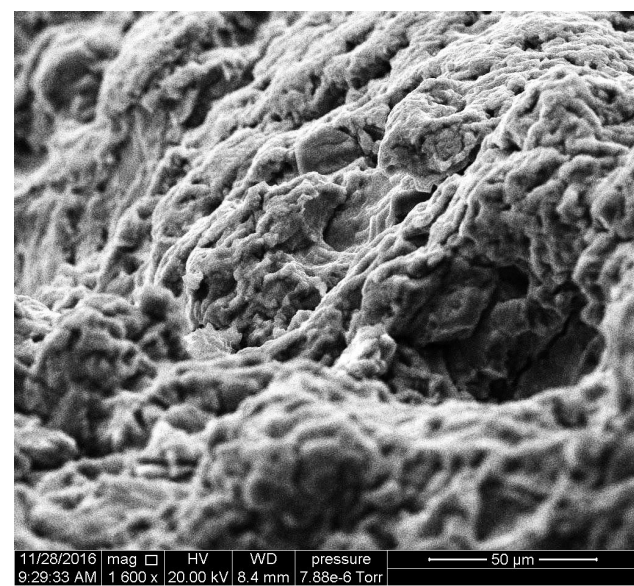
1600X

Direct evidence of cavitation damage on wear ring
