Failure Analysis of Jet Boat's Wear Ring and Impeller.

Properties of Materials (ME 3034) December 2nd 2016

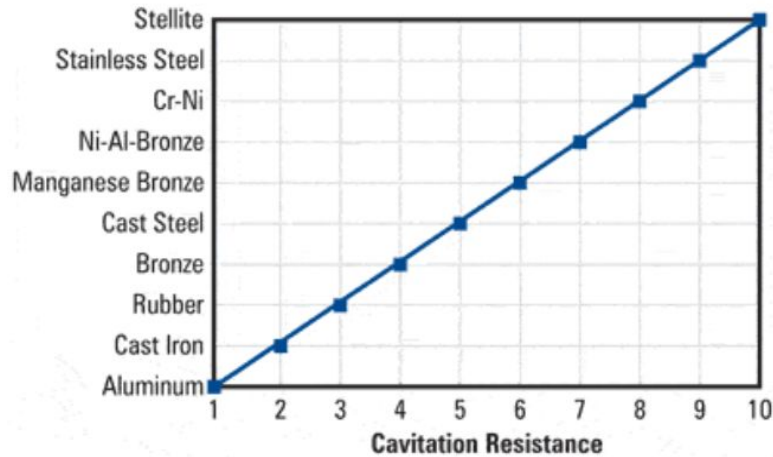
Summary Graph 1

The impeller is made of a stainless-steel alloy that the manufactures call X7 and the wear ring is made from an aluminum alloy called XK360. Our main theory for failure is cavitation and this graph below indicates that while the aluminum wear ring is designed to take less cavitation damage then the stainless steel impeller.

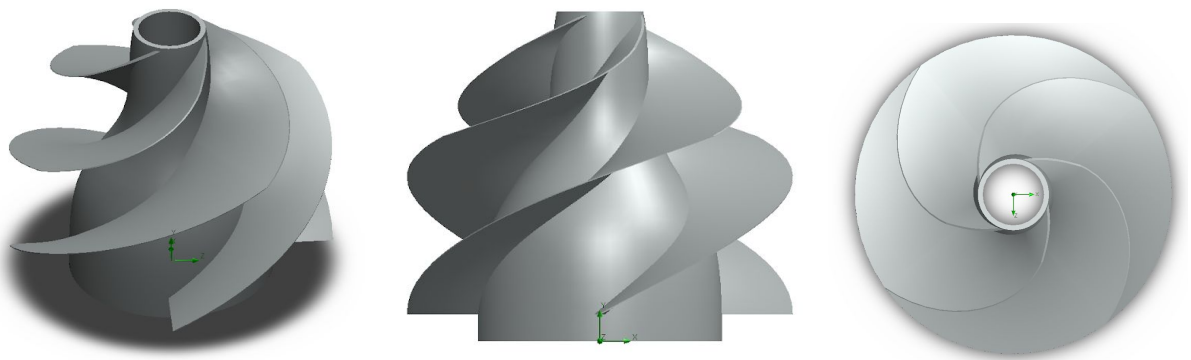
Impeller modeled in solidworks (CFD figures 1,2,3)

To better analyze what is happening with the fluid inside the wear ring, a Computational Fluid Dynamics (CFD) analysis was run to understand the velocity, pressure, and vapourization inside the part. We modeled the impeller in *solidworks*, figures 1,2,3, and the wear ring as a basic circular tube. We then ran an analysis using the fluid simulation in *solidworks*. For this simulation the fluid was modeled as freshwater, and the impeller was running at 500rad/s (4775 RPM). The max RPM of the engine is listed as (5160-5650) RPM. It is important to note that when *solidworks* models a rotating part, the part is actually stationary relative to other parts. And the fluid moves. For this case, the impeller and wear ring are relatively stationary, with a fluid boundary rotating around the impeller. This is evident in the side view pictures such as figure 4 where the top of the impeller has a noticeable dome, which is the fluid rotation boundary. Additionally, in the last figures (CFD figure 11,12), the wear ring and impeller are stationary relative to one another, which means the analysis will be modeled as if looked at a single point in time.

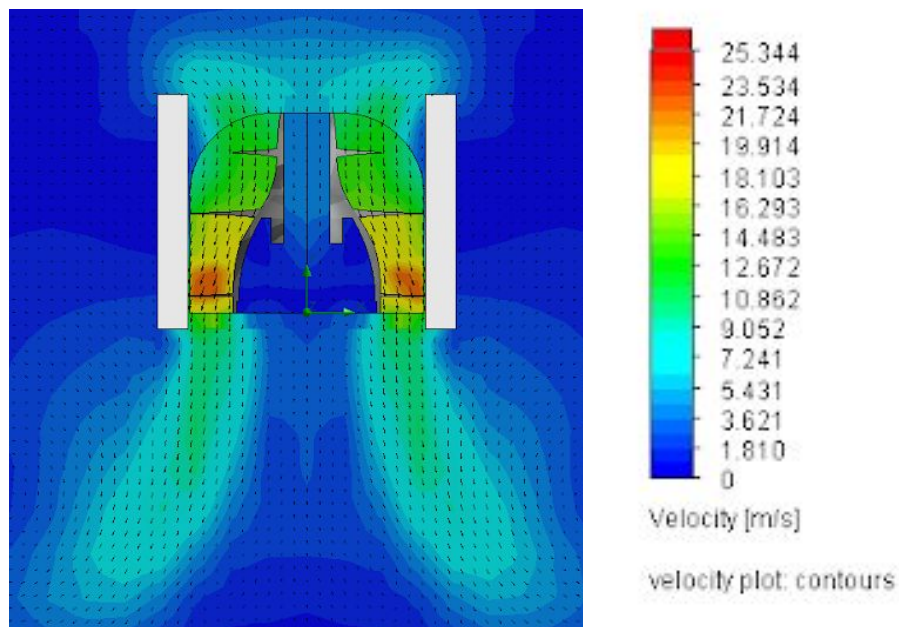
Velocity contours: (CFD Figure 4)

The Contour plot, figure 4, and trajectory plot, figure 5 models the flow of fluid through the wear ring and the velocity associated with this flow. At the speed modeled (500rad/s) you can see the max velocity is ~25m/s localized right at the bottom of the impeller.

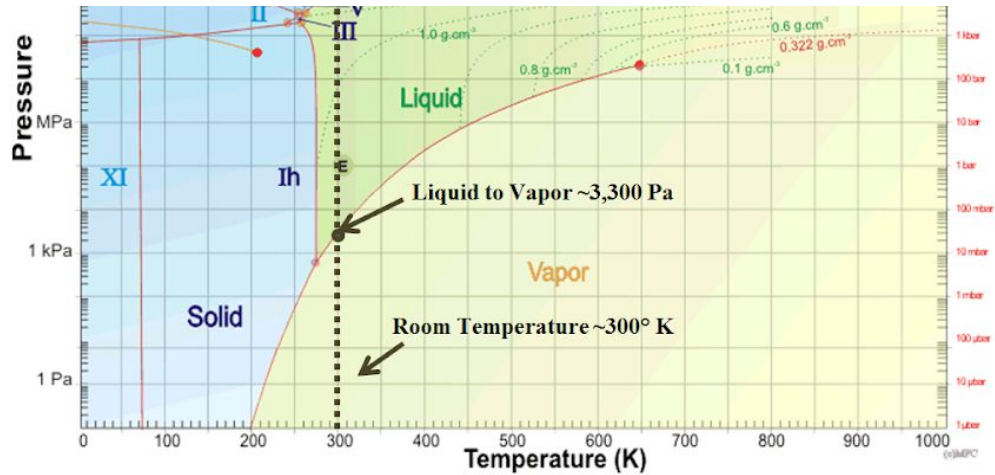
Phase Diagram of water (CFD Figure 7)

The pressure plot below, figure 6, models the pressure of the fluid as it flows through the wear ring. At room temperature fluid normally vaporizes at less than 3,300Pa. On this diagram you can clearly see areas as low as ~7,000Pa or less right near the blades. While this does not definitively show vaporization, it is so close to the vaporization point compared to normal 101.3kPa pressure, that there is at least partial vaporization. Additionally the temperature from the engine means that the fluid will likely start to vaporize at higher pressures as seen in the phase diagram, figure 7.

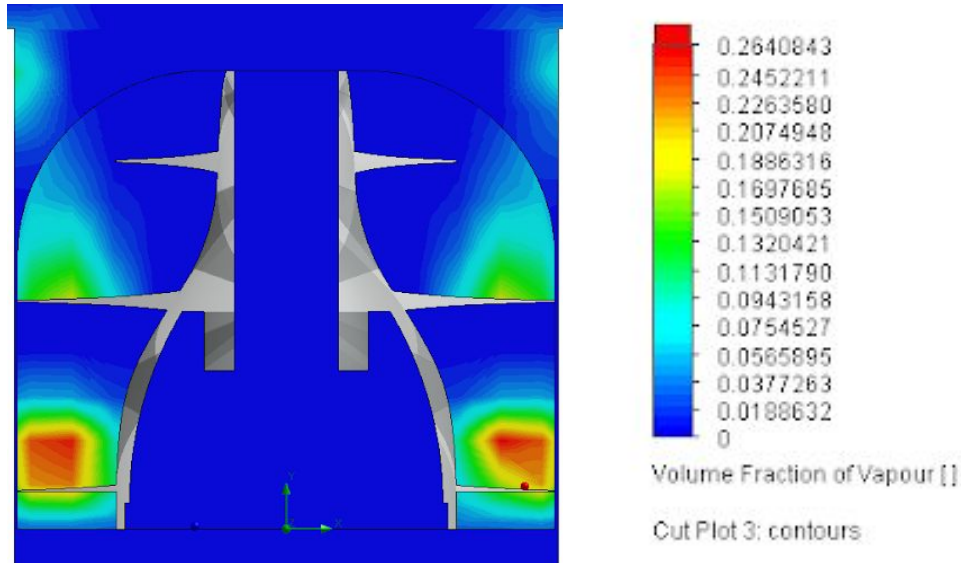
fluid vaporization plot cross section (CFD Figure 10)

Figure 8 and Figure 9 both model the percent of vapor on the impeller. Figure 8 indicates there is at the highest point ~60% vapor. This shows that there are a lot of bubbles that are forming and subsequently crash into the metal of the impeller causing damage when they turn back into liquid. This is indicative of cavitation. It also has the highest percent vaporization in the same region on the real part, showing that this is a good model to predict the damage.

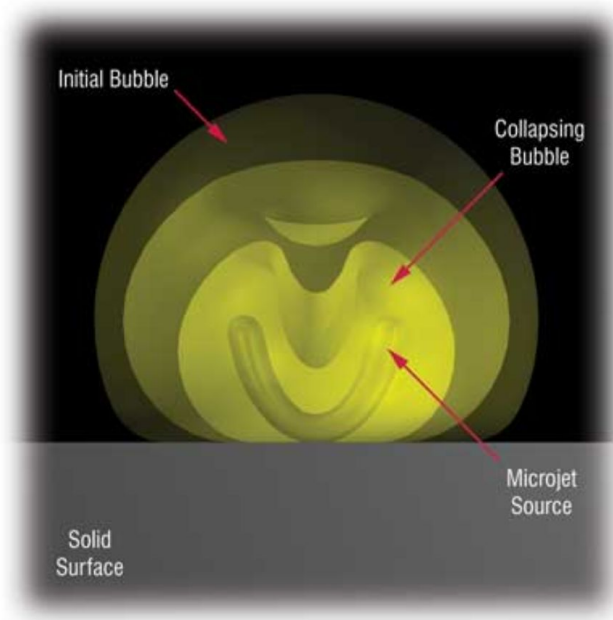
Discussion Figure 1: Microjet formation at surface of cavitation damage
